MM KEMBLA ENVIRONMENT INCIDENT UPDATE 29.04.2013

MM Kembla has been operating at its Port Kembla site since 1916. In 2010 a new Horizontal Billet Caster (HBC) was commissioned.

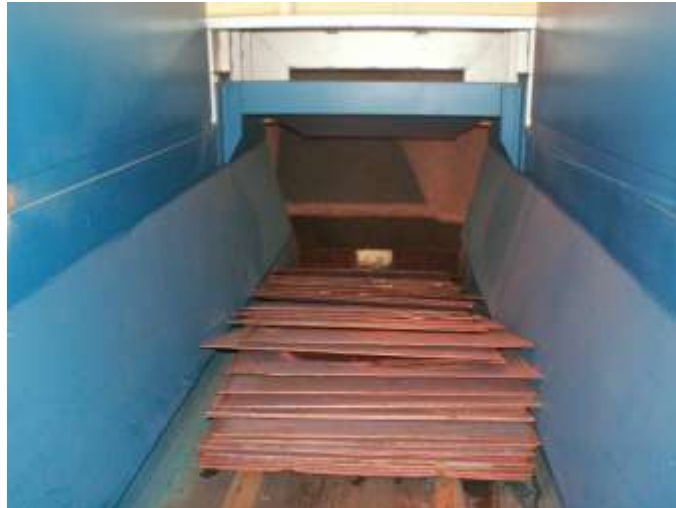
Feedstock to the billet caster is typically “cathodes”. Cathodes are supplied to MM Kembla in sheets of 99.9% pure copper that are typically around a metre square and four to five mm thick.

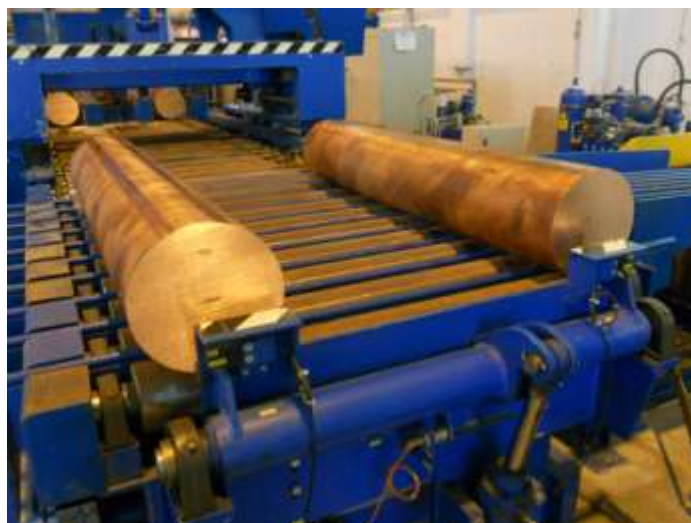
A horizontal billet caster is an electrical induction heating process that melts pure copper to produce a continuous solid, round log (billet) of copper, cast horizontally. Billets produced by the billet caster are 248 millimetres in diameter and they are cut into lengths of 1.35 metre long and used as feed stock for the tube mill.

The billet caster typically operates for two or three 80-100 hour campaigns per month. This is 3-4 days about every fortnight. The horizontal billet caster’s nominal capacity is 16,800 tonnes of copper products per annum (tpa). When the billet caster is not casting the molten metal is kept at temperature with an insulation covering protecting the surface.

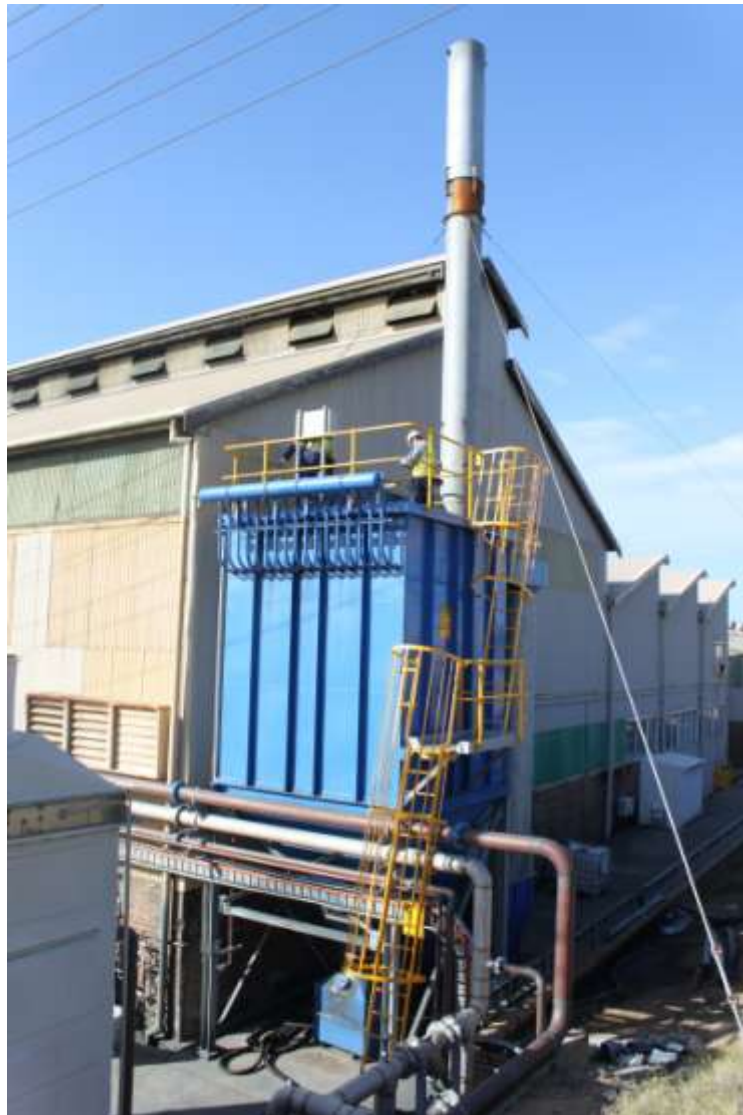
Attached to the billet caster is a bag house, which could be described as a giant vacuum cleaner. Emissions from the melting process are drawn through the bag house which contains around 250 filter bags which are designed to filter particulate matter from the air stream.
